Pilot Reported Roughness: Roughness Investigation and Repair

By: Kevin Chee of the Greater Toronto Airport Authority
Michael Gerardi of APR Consultants

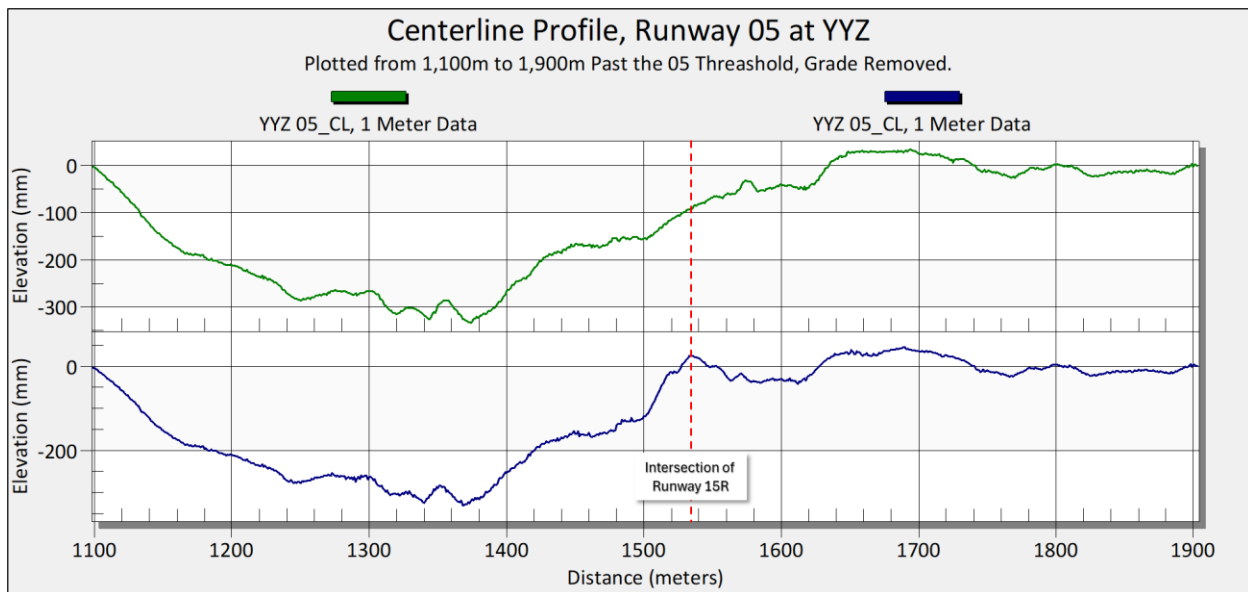
Early in 2011, the Greater Toronto Airport Authority (GTAA) resurfaced Runway 05-23 at Toronto's Lester B. Pearson International Airport (YYZ). Not long after opening the runway, Air Canada began getting pilot complaints of runway roughness when operating from Runway 05-23. The aircraft's Flight Data Monitors began registering excessive loads (1.70g) at the center of gravity of their 777 aircraft in response to roughness at the intersection of Runway 15R. APR was asked to investigate and identify the area of roughness, and to assist the GTAA in developing a repair that would eliminate the bump without compromising needed watershed performance for Runway 15R. Figure 1 illustrates two plots: one of the runway's profile before the overlay and one of the changes created by the overlay. Figure 2 illustrates the aircraft's response to the measured profile in the vicinity of the Runway 15R intersection. Accelerations near 1.0g for this simulation, well over the +/- .40g threshold. Please note the undulations (multiple event roughness) on either side of the 15R intersection.

Figure 1. The measured runway profile of Runway 05-23 before overlay (top) versus after the overlay (bottom).

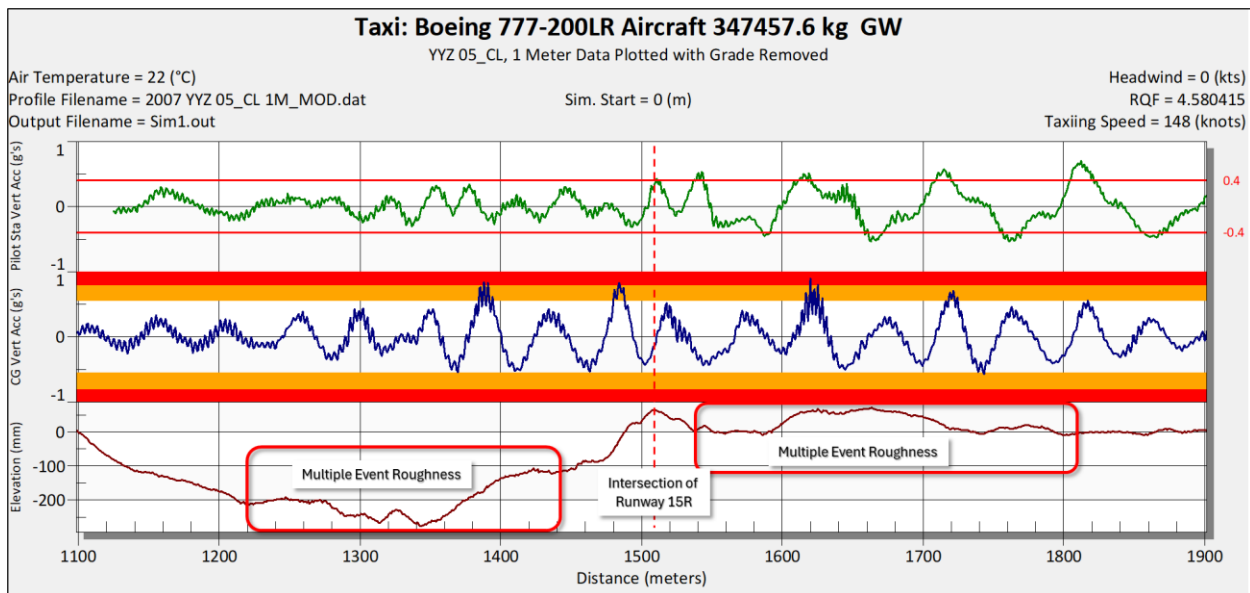
the aircraft did not respond to just one event, the intersection with 15R, but was responding to a series of events that led up to the 15R intersection. The bumps and dips preceding the intersection caused the aircraft to “rebound” from those events as it encountered the up side of the 15R intersection. Figure 2 illustrates the measured profile of the affected area as measured in 2007 (top) and the new profile, measured after the 2011 overlay. Note the difference in pavement profile located around the 1,540-meter mark.

Figure 2. Aircraft simulation of a 777-200 encountering the intersection of Runway 15R.

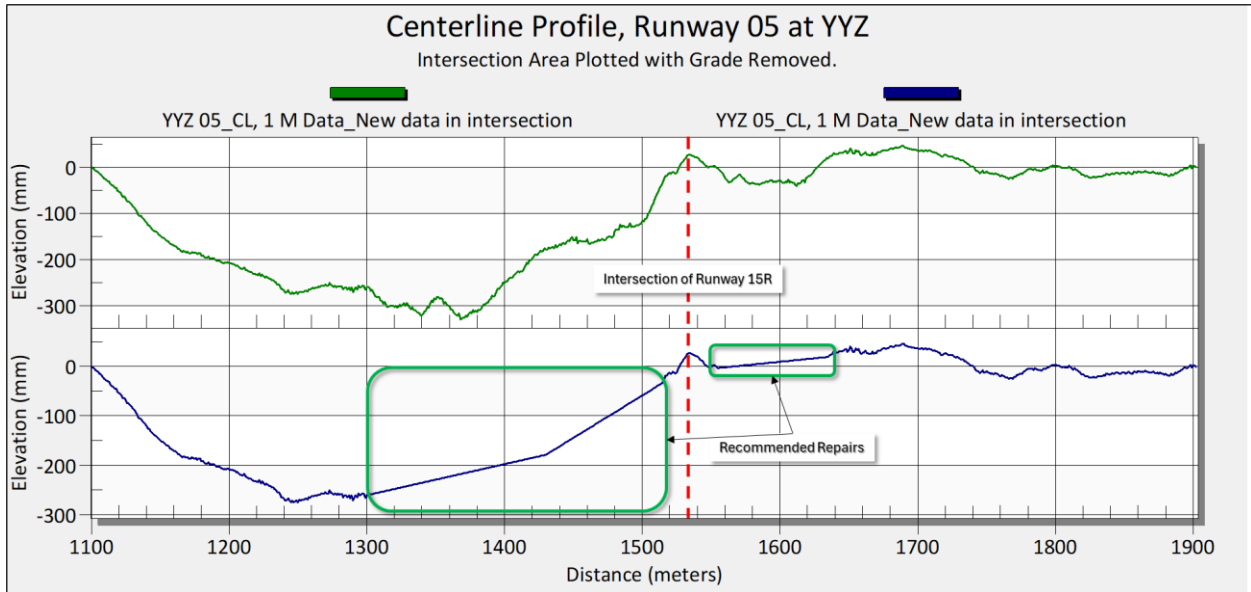
Figure 3. The profile of Runway 05-23 after the 2011 overlay (top) versus the proposed repair designed by APR (bottom).

Once the bump locations were identified, APR began an iterative process of making straight line repairs to the measured profile. This process involved making conservative modifications (analytically) to the profile, then simulate an operation, in this case, a high-speed taxi using a model of a Boeing 777-200. This process is repeated until the desired ride quality is achieved. Figure 3 illustrates the notional changes to the runway's profile (bottom of plot) versus the original profile (top). Once the optimum repair was designed, the repair profile was provided to the GTAA for use by their paving contractor. APR's simulations indicate that the repaired profile yields a dramatic improvement in ride quality for the 777 aircraft. As Figure 4 shows, the aircraft's accelerations are well within the .40g threshold of acceptability.

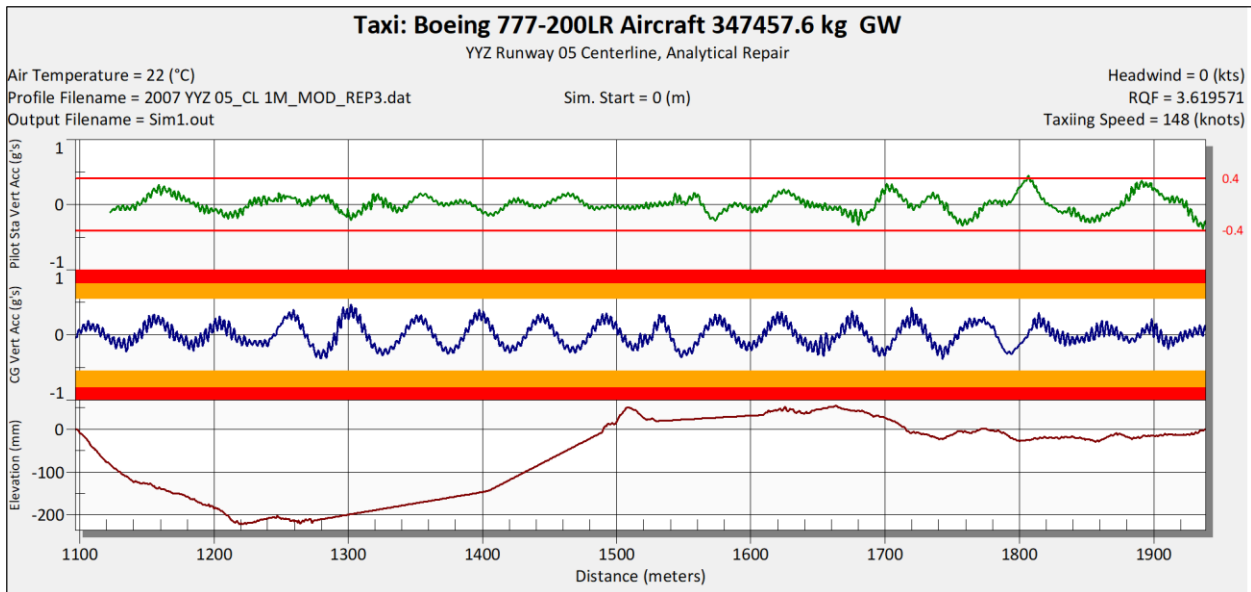
Figure 4. Aircraft simulation of a 777-200 performing a constant-speed taxi over the *repaired* profile with dramatically improved results.

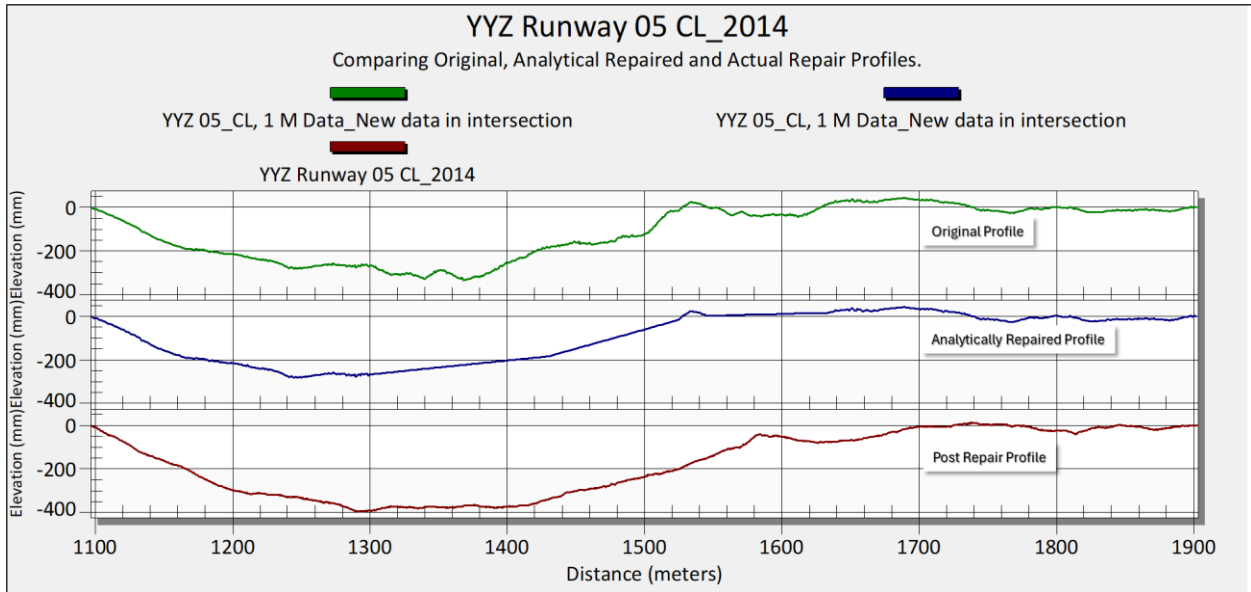
Figure 5. The original 2011 overlay profile (top) compared to APR's engineered design (middle) and the as-built repair (bottom).

Later in 2014, APR was asked to re-assess Runway 05-23 to update the pavement management program at YYZ. Using the Auto Rod and Level, three lines of survey were measured of this runway. Figure 5 plots the post repair profile of the affected area compared to the original problematic profile and the analytical repair APR provided to the GTAA. When assessing the ride quality of the actual repair, the ride quality improved significantly, eliminating pilot complaints (Figure 6).

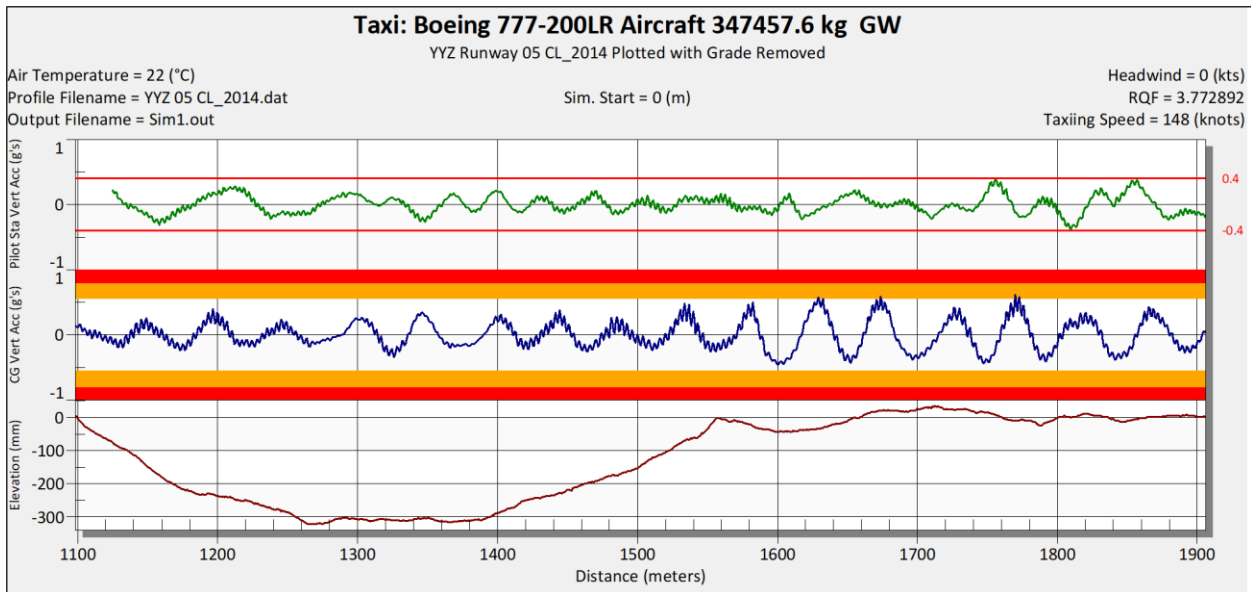
Figure 6. Aircraft simulation predicts significantly improved ride quality for the newly repaired profile.
